APPENDIX D
Arborist Report

Subject: Arborist Report for the Eldredge Property/Farmstead Project Site, City of Vacaville, California

Arborist Report for the Eldredge Property/Farmstead Project Site

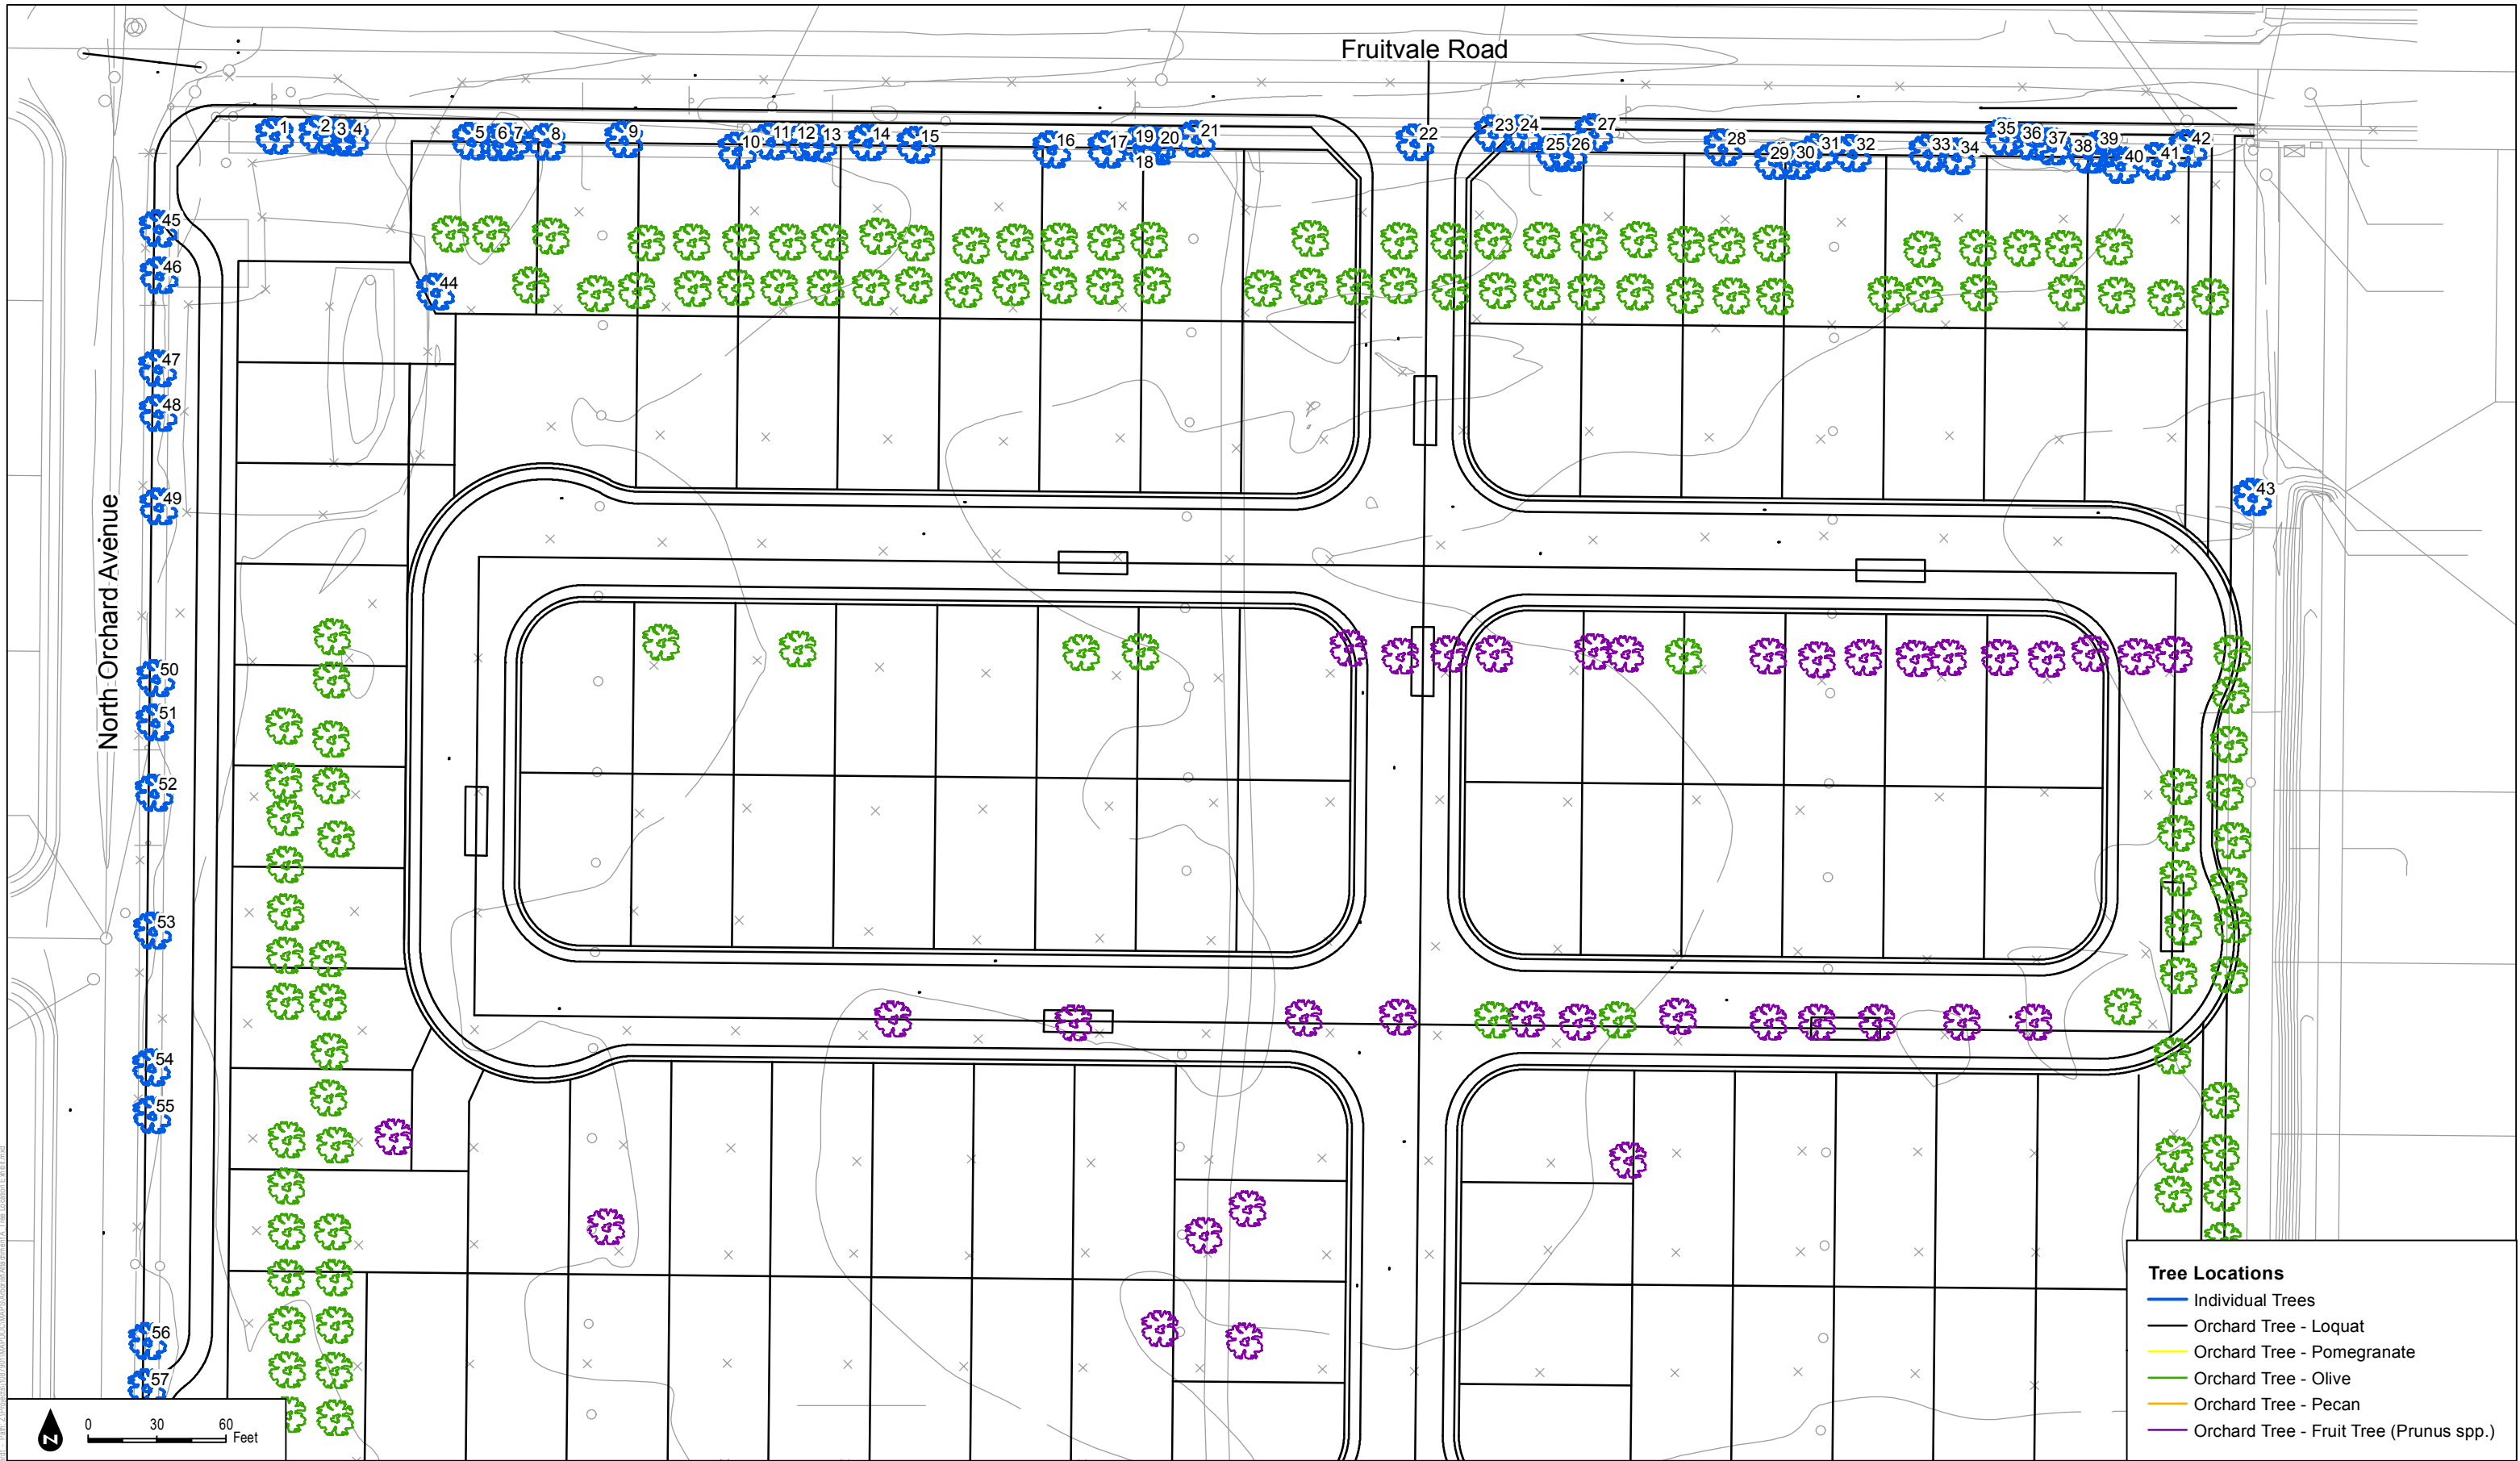
Attachment A-1
Tree Locaton Exhibit

A total of 533 trees meeting the size criteria identified in the City's Standard (196 non-orchard trees and 337 orchard trees) were mapped on the project site, including 47 different species. Tree quantities are presented in Table 1 and tree size and attribute data is presented in Attachment B. Tree impacts were determined by evaluating surveyed tree locations relative to proposed project development areas. Seven (7) trees not subject to construction-related impacts were recommended for removal due to poor health and/or structural condition. Additionally, the project's landscape architect and the City identified 20 trees for removal based conflicts with maintenance criteria. Impact totals presented herein are based on the project's conceptual site plan as of the date of this report. The actual number of trees that are subject to impact may change if site plan modifications are made. Table 1 summarizes tree preservation and removal totals, by species. A total of 396 trees (95 non-orchard trees and 301 orchard trees) would require removal and 137 trees (101 non-orchard trees and 36 orchard trees) would be retained on site. It is anticipated that most trees retained on site would require some level of canopy or root pruning or may be subject to construction-related dripline encroachment. Recommendations to minimize impacts to retained trees are provided in Attachment C.
