Additional Phase II
Environmental Site Assessment

**ADDITIONAL PHASE II
ENVIRONMENTAL SITE ASSESSMENT
On
Former Green Tree Golf Course
999 Leisure Town Road
Vacaville, California 94538**

Project No. 2018-18

June 24, 2021

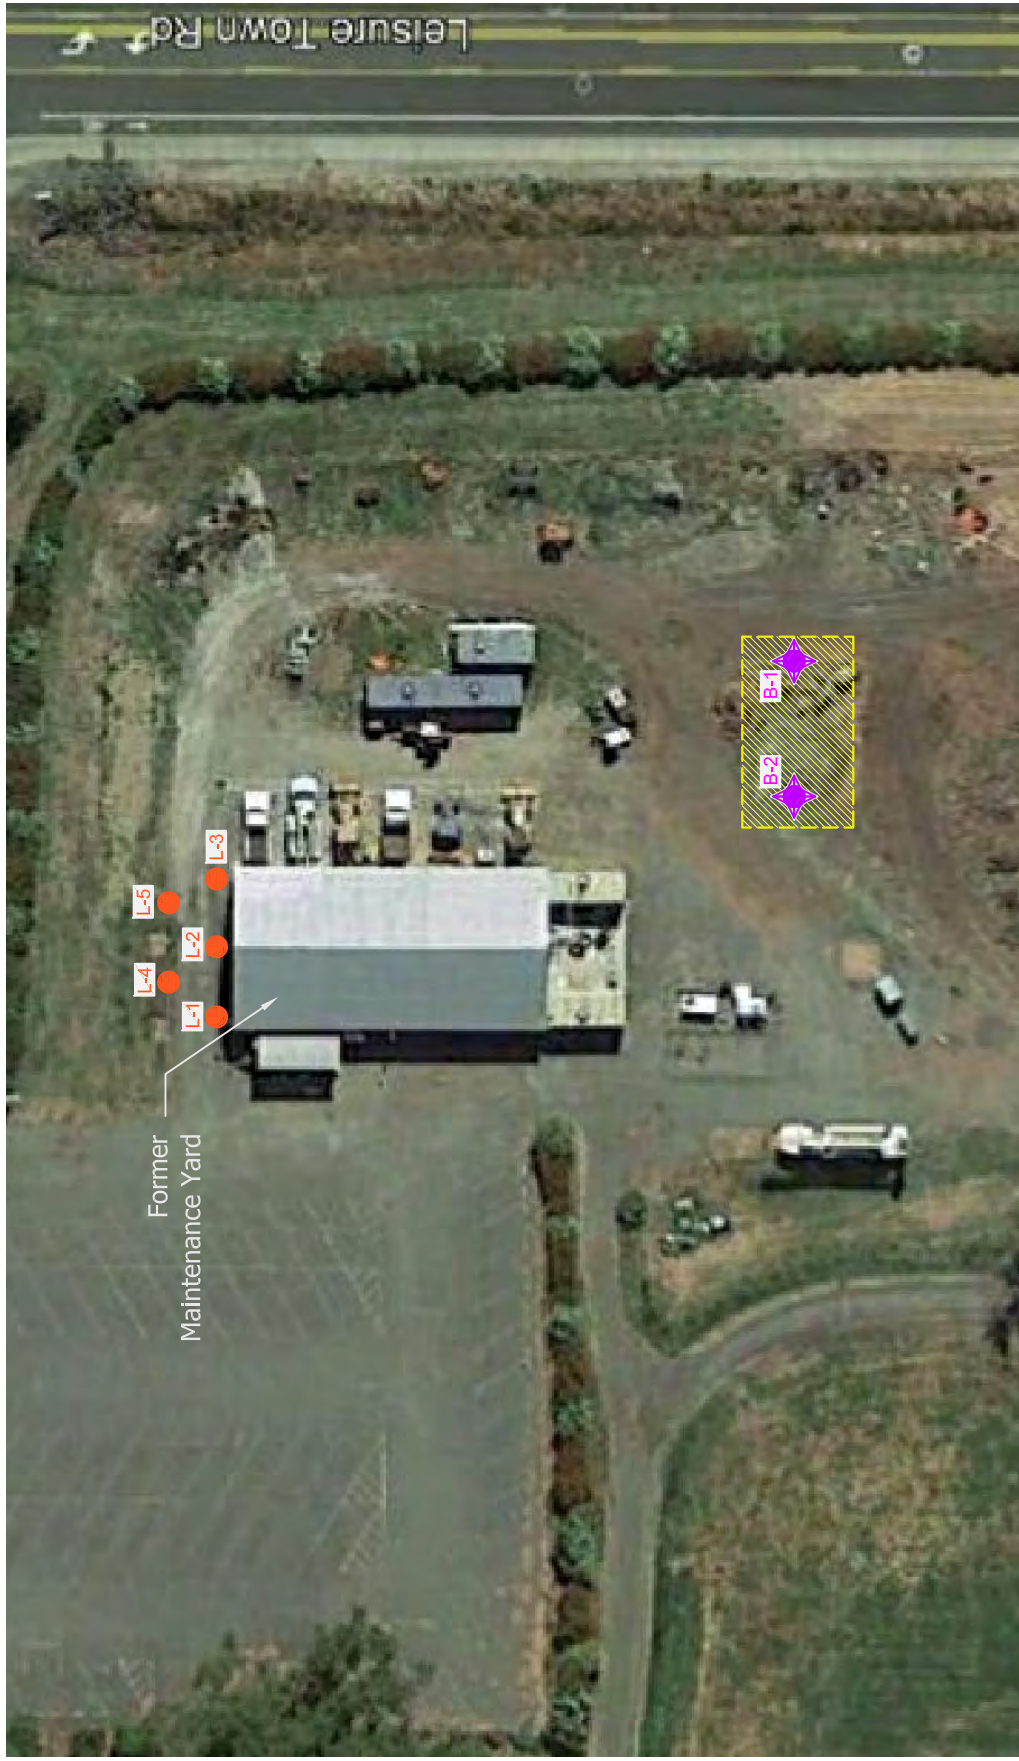
3

Acetate liners were extracted from all borings for description and laboratory analysis. Soil samples were hand collected at 10-, 15-, and 20-foot bgs by hand using a hack saw, in which the sample lengths were measured using a ruler, and the cut sample ends were covered with Teflon tape, capped, labeled, and placed within a pre-chilled ice-chest for temporary storage. The locations of borings B-1 through B-25 are shown on Figure 3, Boring Location.

A *GeoSolve, Inc.* field geologist, equipped with a hand-auger, visited the northern portion of the former maintenance yard building and advanced five shallow borings (L-1 through L-5) to approximately 2 feet bgs. Soil samples were collected using laboratory supplied clean glass jars, which were sealed, labeled, and placed within a pre-chilled ice chest for temporary storage. The location of the shallow borings L-1 through L-5 are shown on Figure 3.

BORING LOCATION

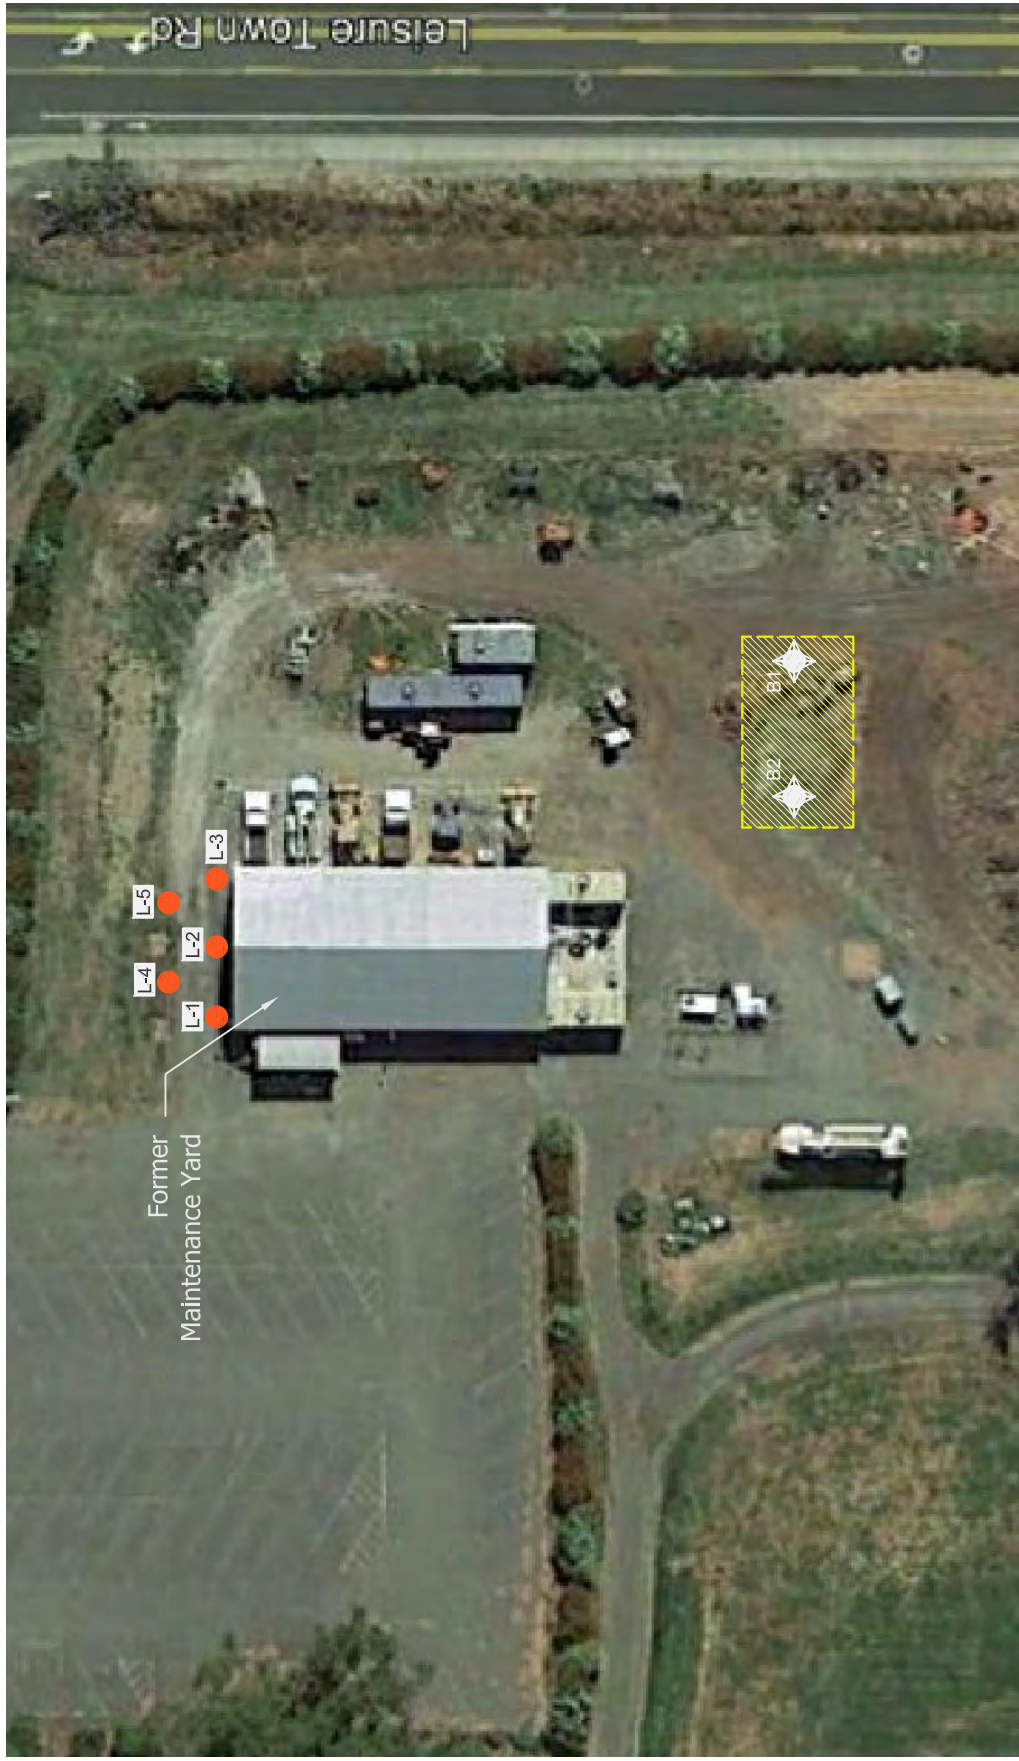
3

BORING LOCATION
