# **Aquatic Resources Delineation**

## Roberts' Ranch

Solano County

June 2016

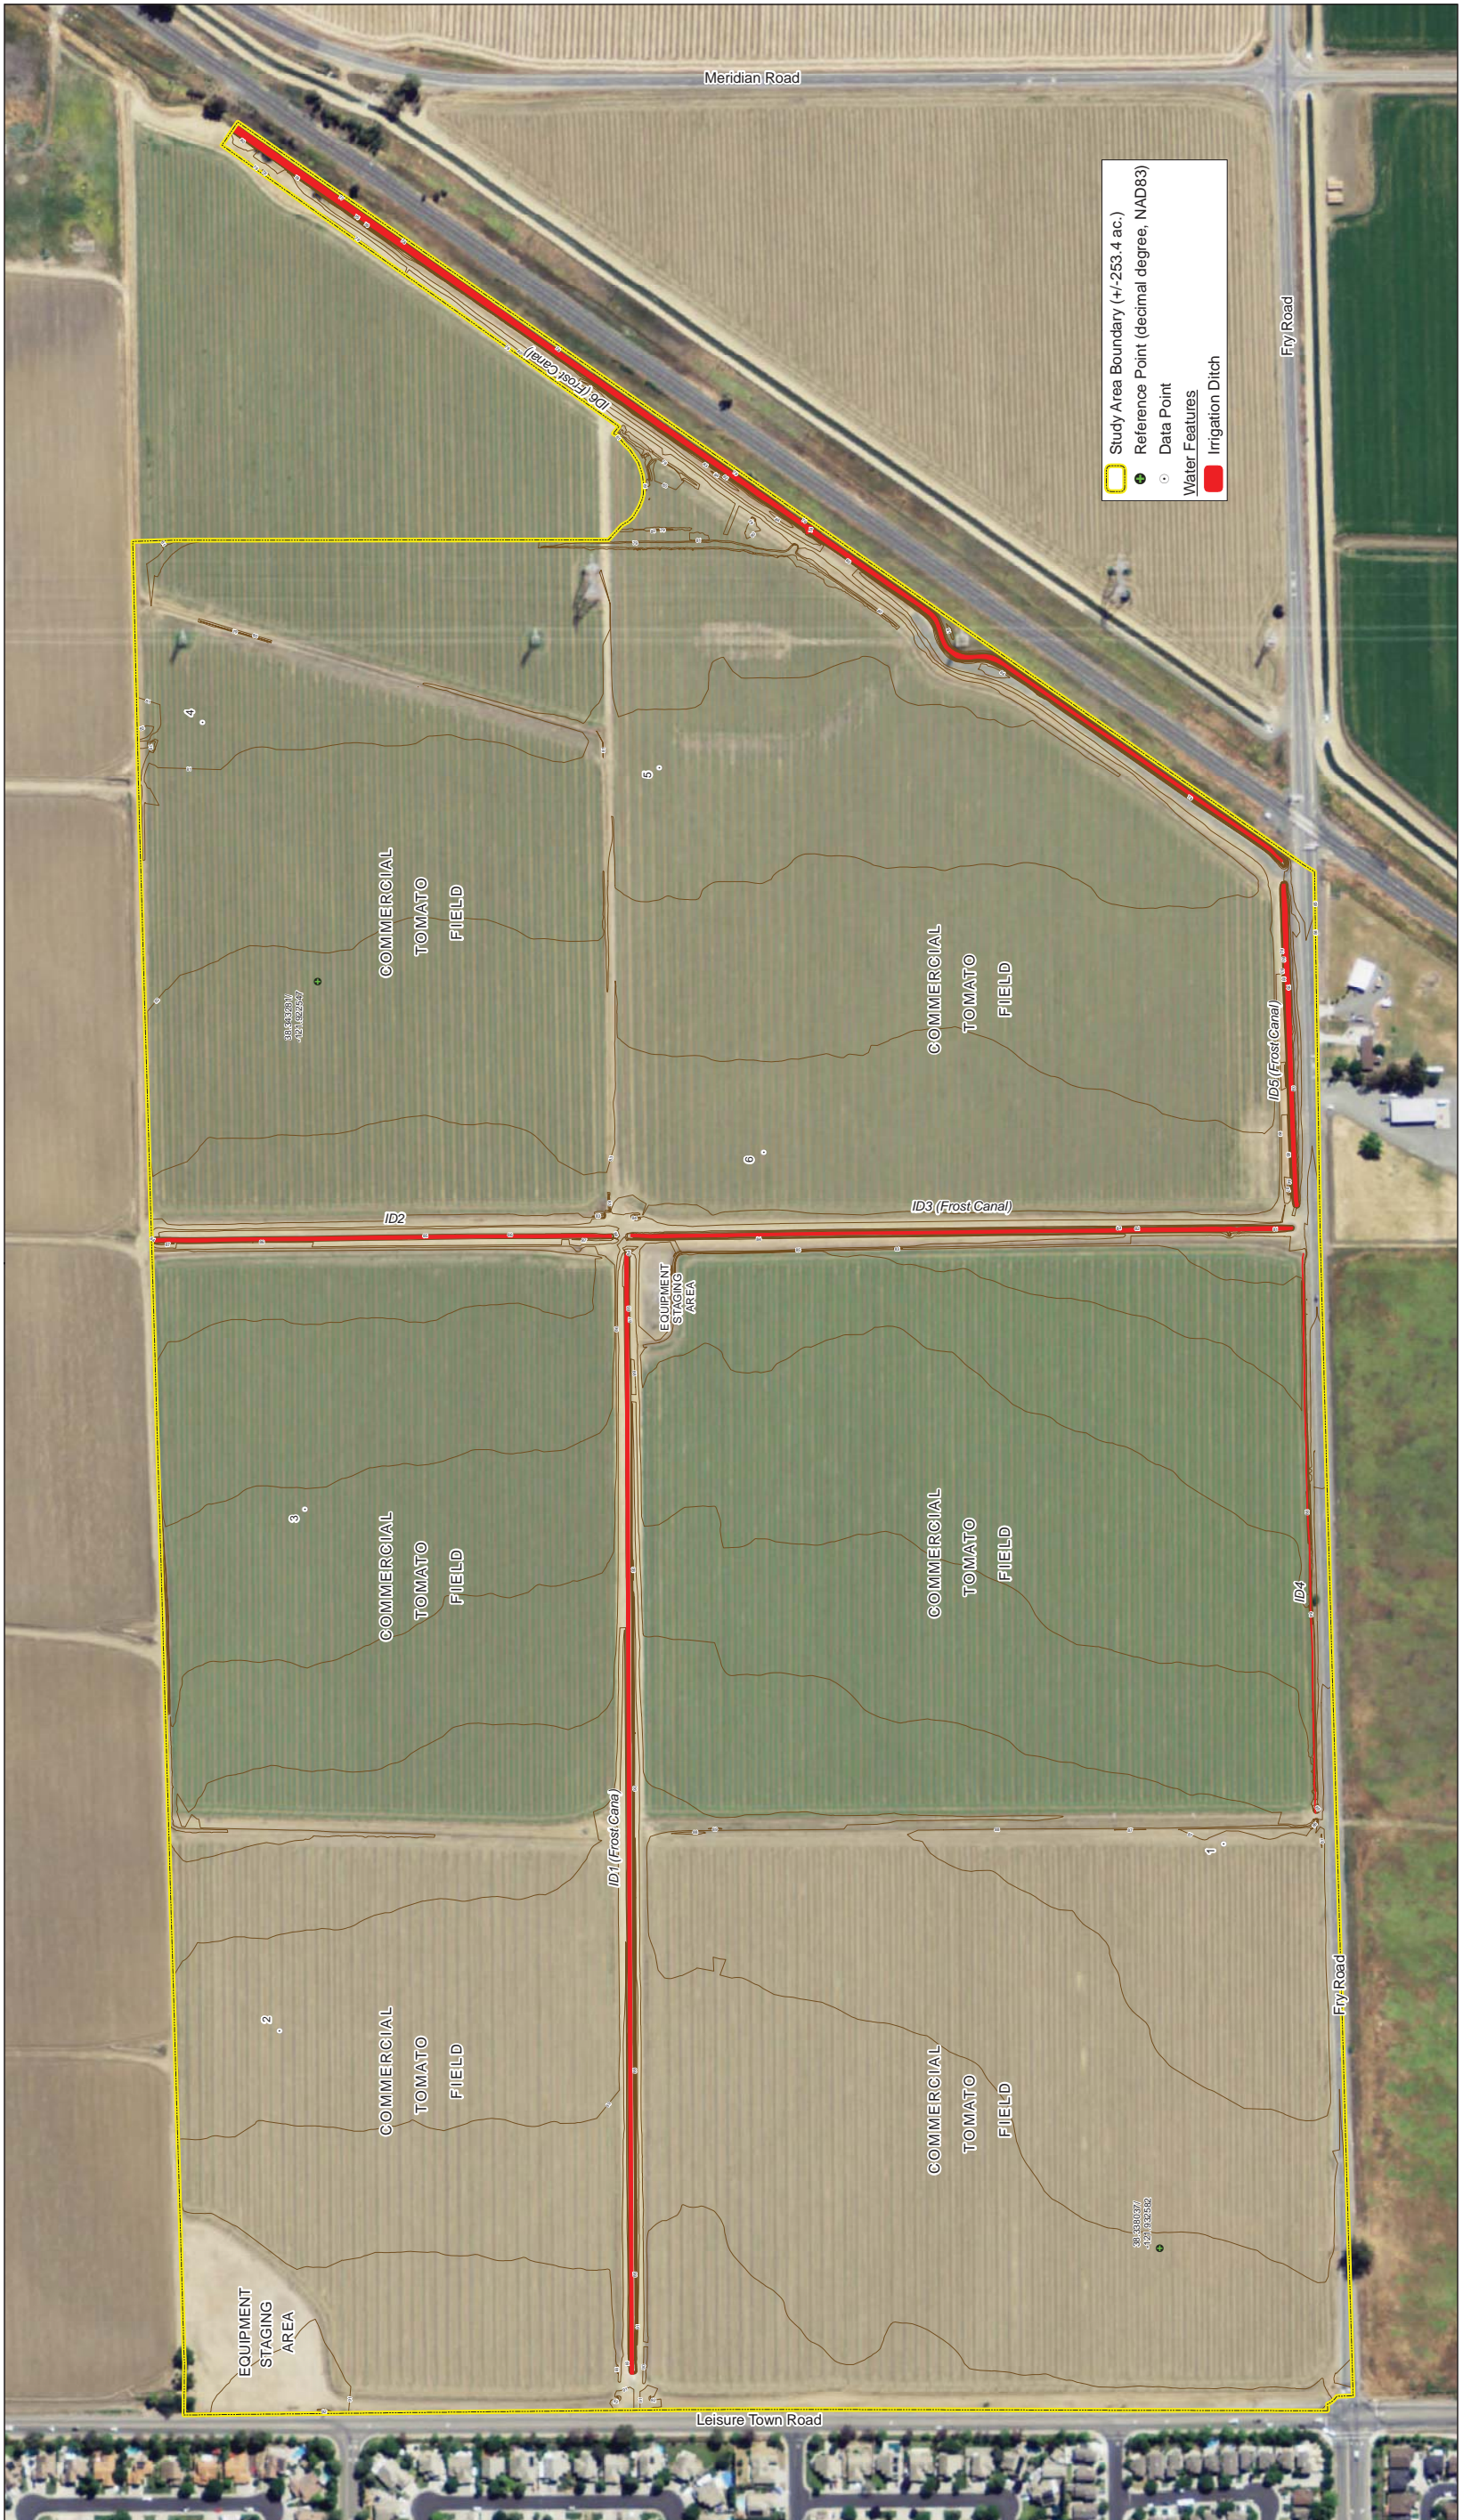
## **Aquatic Resources Delineation Map**

Irrigation Ditches	Ref. No.	Area (ft <sup>2</sup> )	Area (ac)
	ID1	20,324	0.467
	ID2	7,264	0.167
	ID3	10,092	0.232
	ID4	1,909	0.044
	ID5	6,511	0.149
	ID6	29,061	0.667
	<b>Total</b>		<b>1.726</b>

A total of 1.726 acres of potential jurisdictional irrigation ditches was mapped within the Study Area. Data sheets are included in **Attachment A**. An aquatic resources delineation map with an inset table of aquatic resource acreages is included in **Attachment B**. A list of plant species observed within the Study Area with their wetland indicator status is included in **Attachment C**, and representative site photographs are included in **Attachment D**. **Attachment E** is the Aquatic Resources Excel Sheet.

Approximately 1.726 acres of irrigation ditches were surveyed within the Study Area. These features displayed a distinct bed and bank as well as an ordinary high water mark within various reaches. None contained water during any of the field surveys. These are maintained irrigation features that mostly lacked significant vegetation. Herbaceous vegetation, when present, included tall flat-sedge (*Cyperus eragrostis*), smartweed (*Persicaria* sp.) and barnyard grass (*Echinochloa crus-galli*). No data points were taken within these features due to their sharp contrast with the surrounding uplands.
